## โรงไฟฟ้าไตรเอนเนอจี ราชบุรี

## Tooth cracked at Bevel Gear in Cooling Tower's Gearbox

### DETAILED SPECTRUM EXCEPTION REPORT

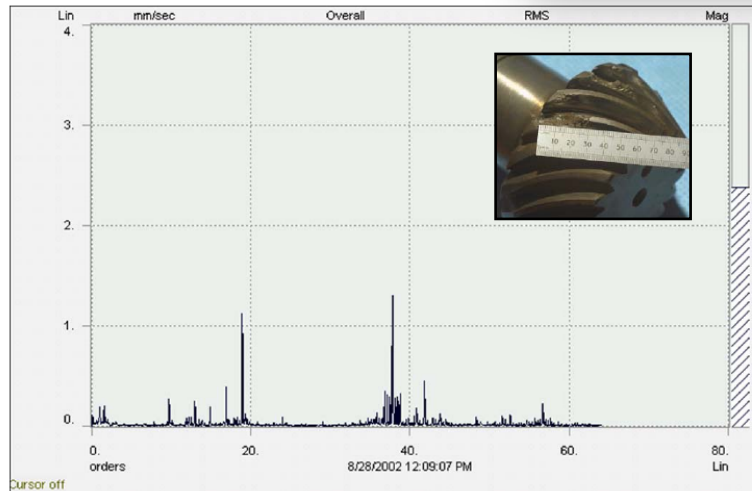
**TRAIN :** TECO  
**MACHINE :** CT Fan  
**DIRECTION :** Axial  
**LOCATION :** Gear Box  
**UNITS :** mm/sec  
**SPEED :** 1500.  
**DATE/TIME :** 8/28/2002 12:09 PM

FREQUENCY	ORDER	AMPLITUDE	SEVERITY	LABEL	DESCRIPTION
1500.	1.695	4.87	Warning	Unbalance Coupling	1 X Motor / Pump
7500.	8.475	3.52	Normal	BPOR	Bearing Outer Race
12000.	13.56	2.91	Critical	Blade Pass Freq.	Blade Frequency
28320.	18.88	3.01	Normal	GMF-1	Gear Mesh Freq.
56640.	37.76	2.05	Normal	GMF-2	Gear Mesh Freq.
