About PdMA

MCEMAX

Why Motor Testing?

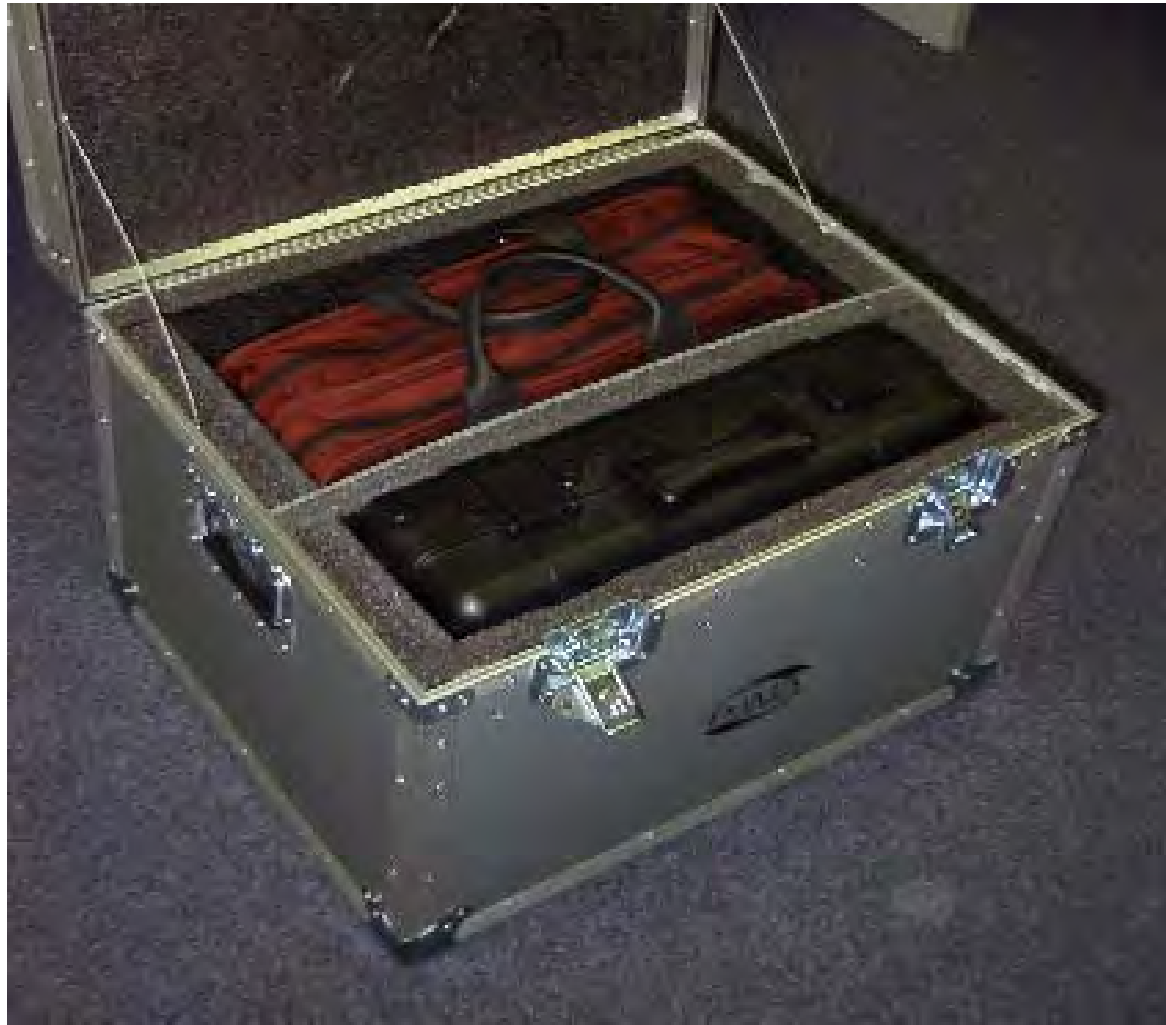
- Shipping Case
- Tester
- Laptop
- Accessory Bag

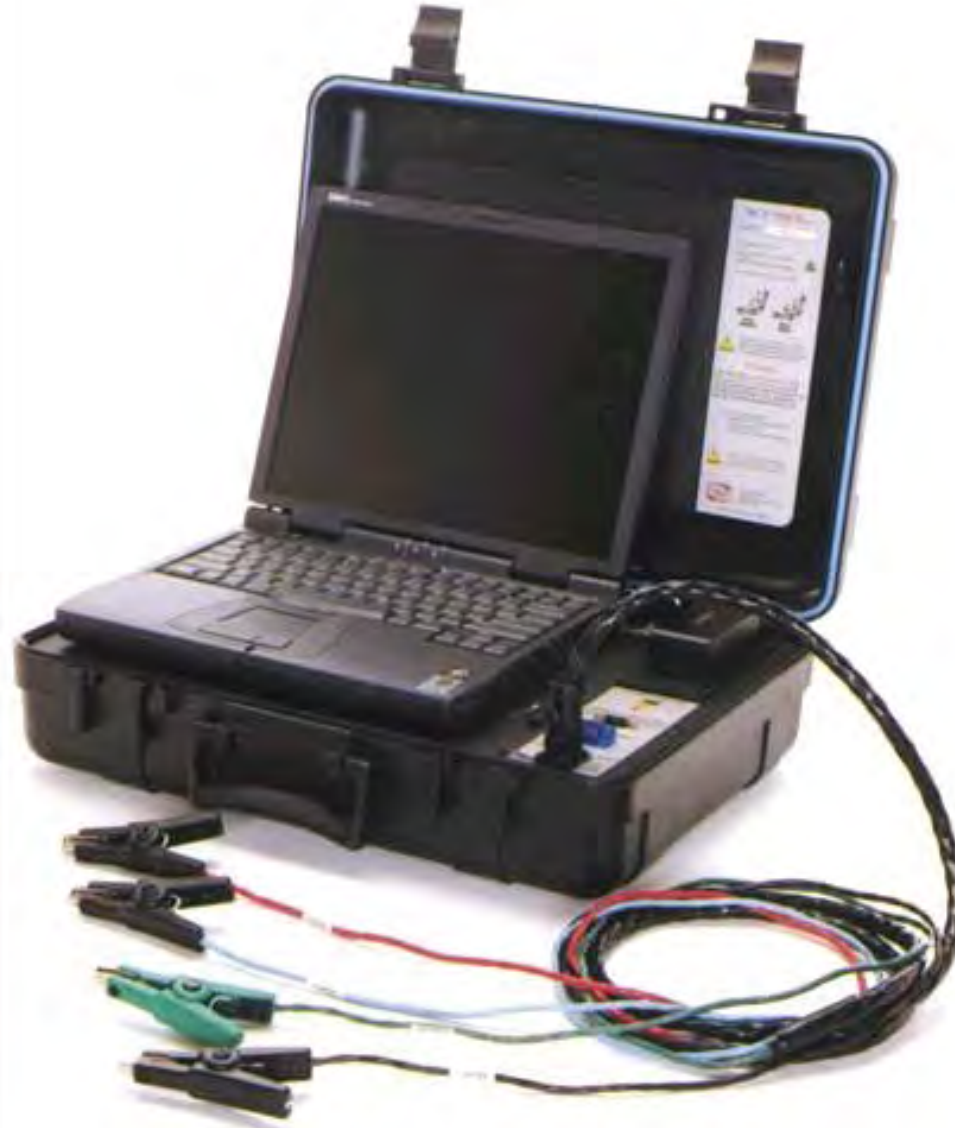
MCE Tester

- Laptop computer
- RJ-45/serial port cable - Interface cable
- Test lead connector - Multi-pin plug
- Tester battery - Camcorder battery
- Battery status display
- Tester board - Located under mold
- Power supply board - Located under mold
- Battery monitoring board - Located under mold

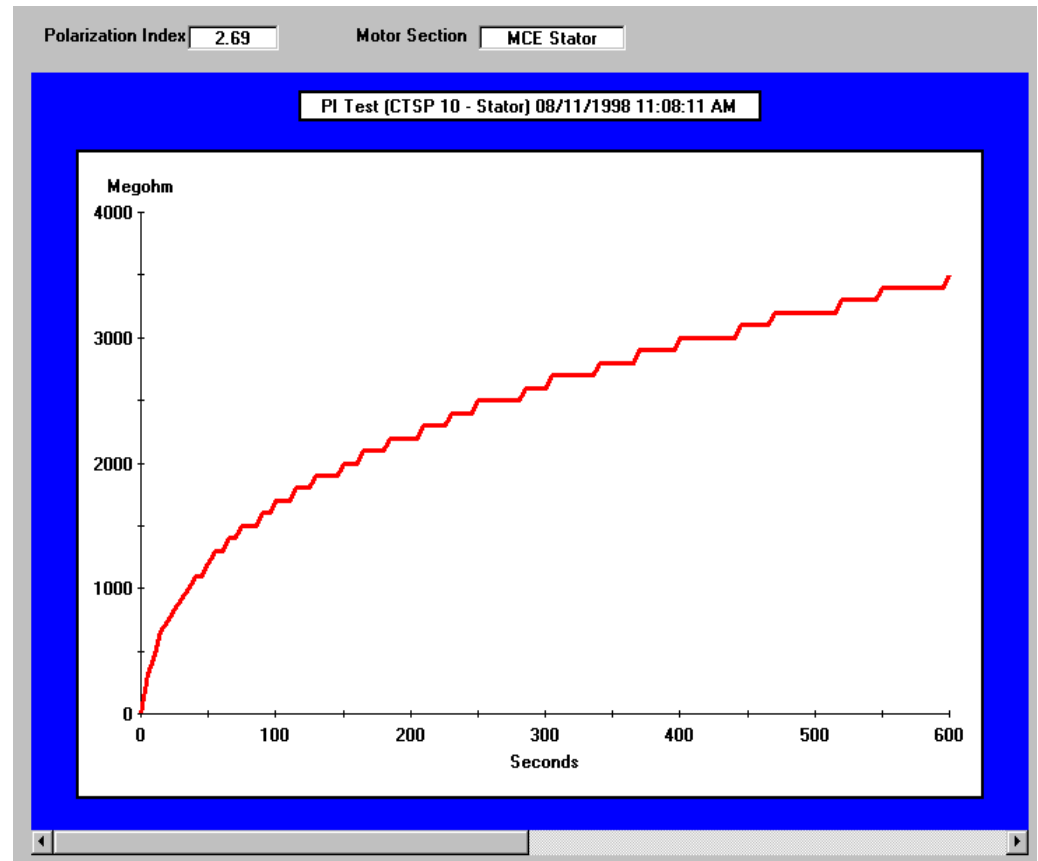
MCE PI & DA

◆ Dielectric Absorption Ratio

- ✦ 1 minute test
- ✦ RTG readings graphed every 5 seconds
- ✦ Ratio of value at 60 seconds to value at 30 seconds

◆ Polarization Index

- ✦ 10 minute test
- ✦ RTG readings graphed every 5 seconds
- ✦ Ratio of value at 10 min. to value at 1 min.

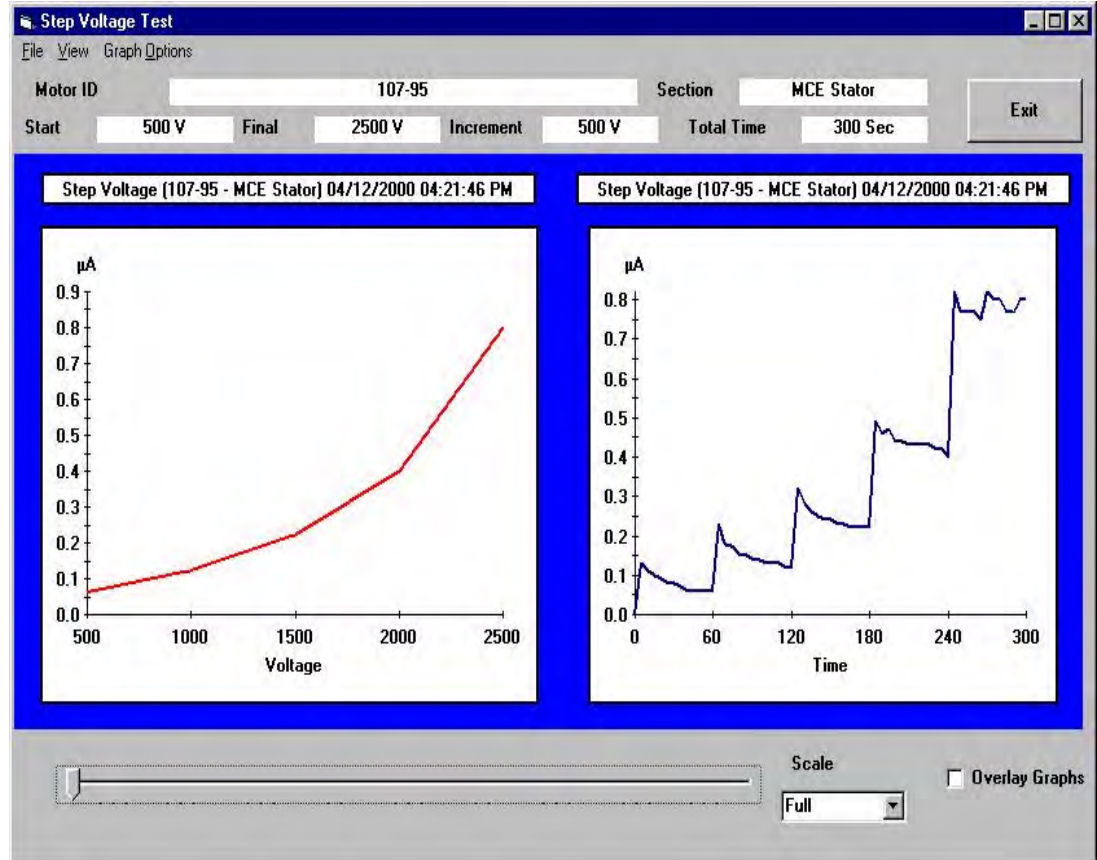
5kV Module

- ◆ Optional MCE accessory
- ◆ Offers Step Voltage Test
- ◆ Safely stresses insulation
- ◆ Less stressful than a hipot test

Surge Test -IEC 34-15 $4 \times V_{\text{Line}} + 5000$ for new motor, 65% of new motor rate for in-used motor
-EAFA $2 \times V_{\text{Line}} + 1000$ for new motor, 75% of new motor rate for in-used motor

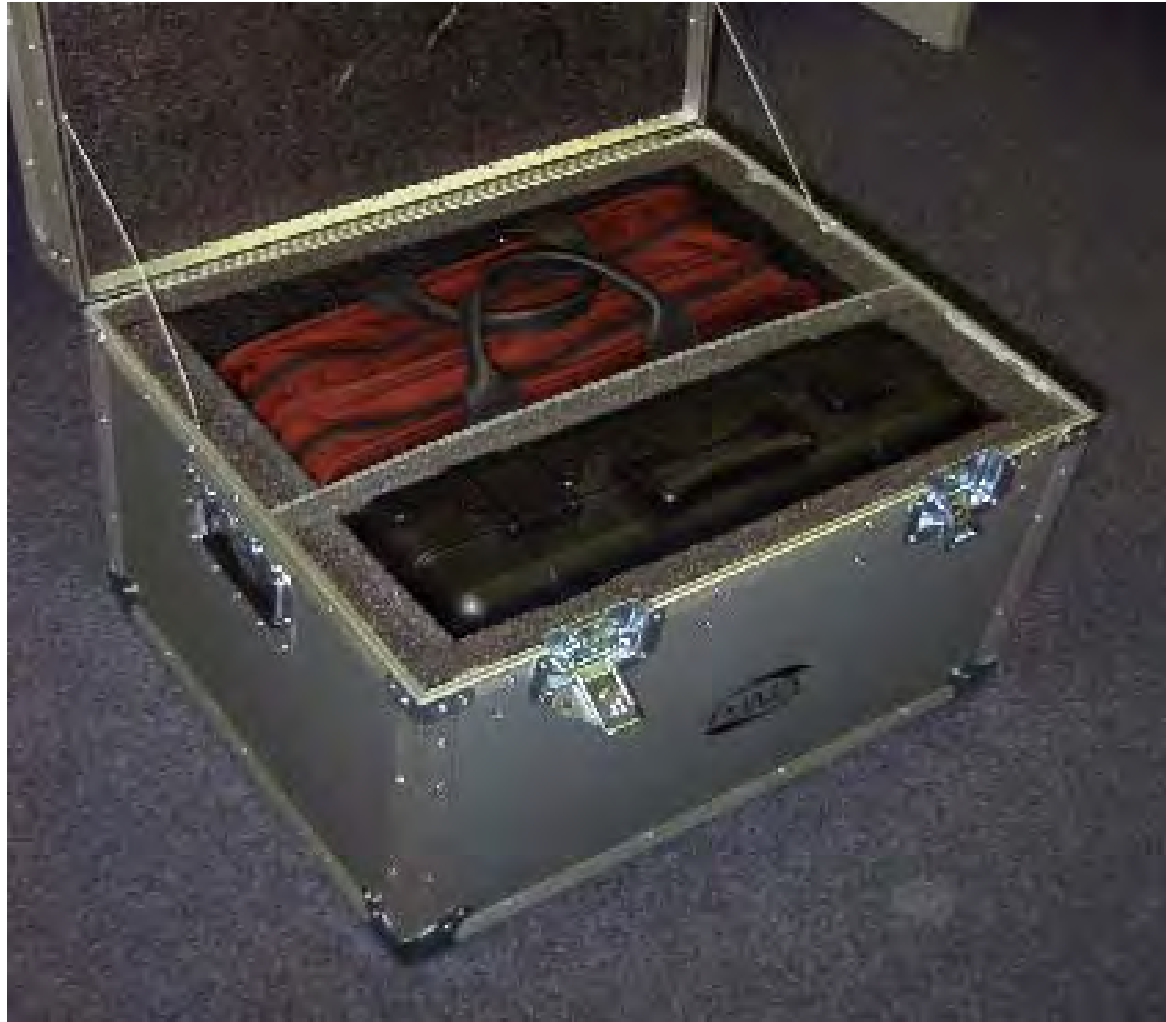
Shipping Case

- **Shipping Case**
- **Tester**
- **Accessory Bag**

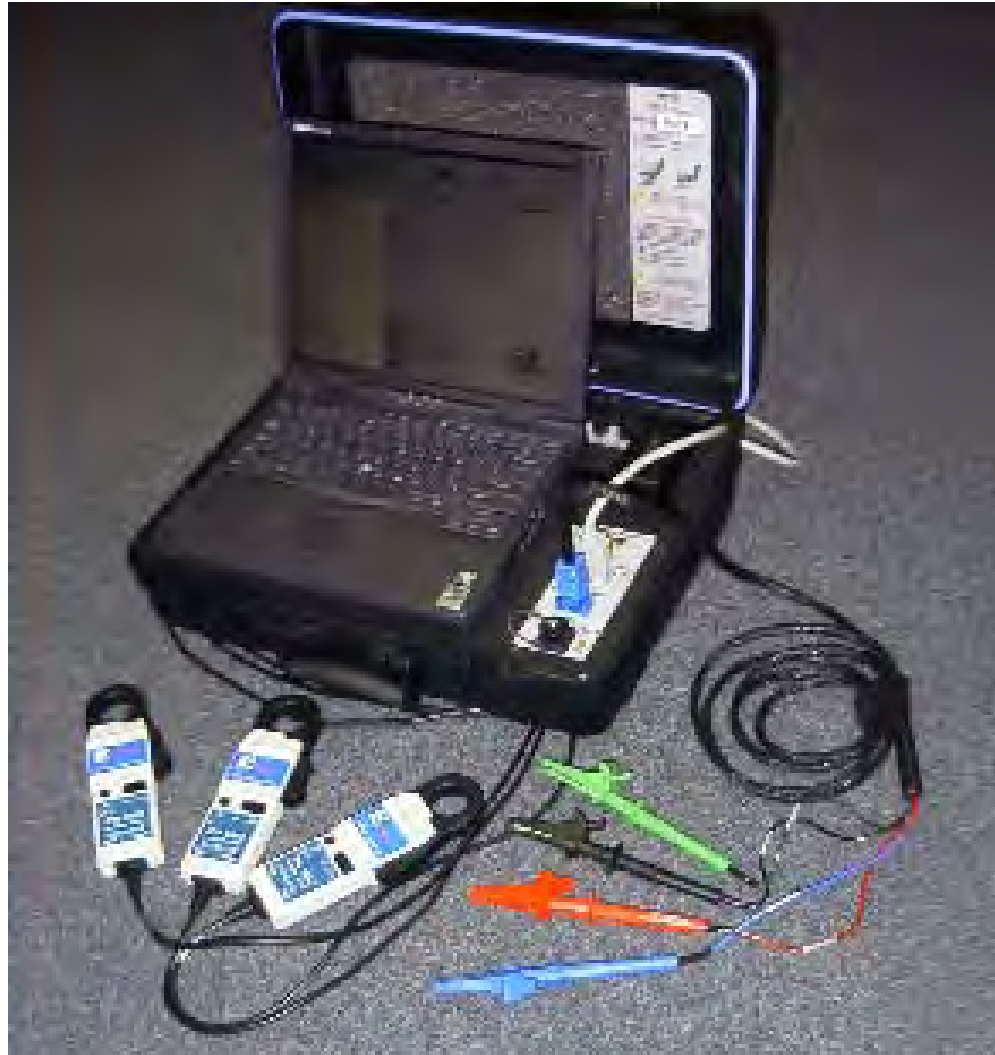
- **Component makeup**
 - Power supply
 - Battery Monitoring board
 - EMAX Tester board
 - Laptop computer
 - Durable carrying case
 - Accessory bag

- Polymer Case
- Laptop computer
- RJ-45/serial port cable - Interface cable
- DAQ - Interface cable
- Current test leads - 3 phases
- Voltage test leads - 3 phases plus ground
- Tester battery – NiMH Camcorder battery
- Battery status display
- Tester board - Located under mold
- Power supply board - Located under mold
- Battery monitoring board - Located under mold

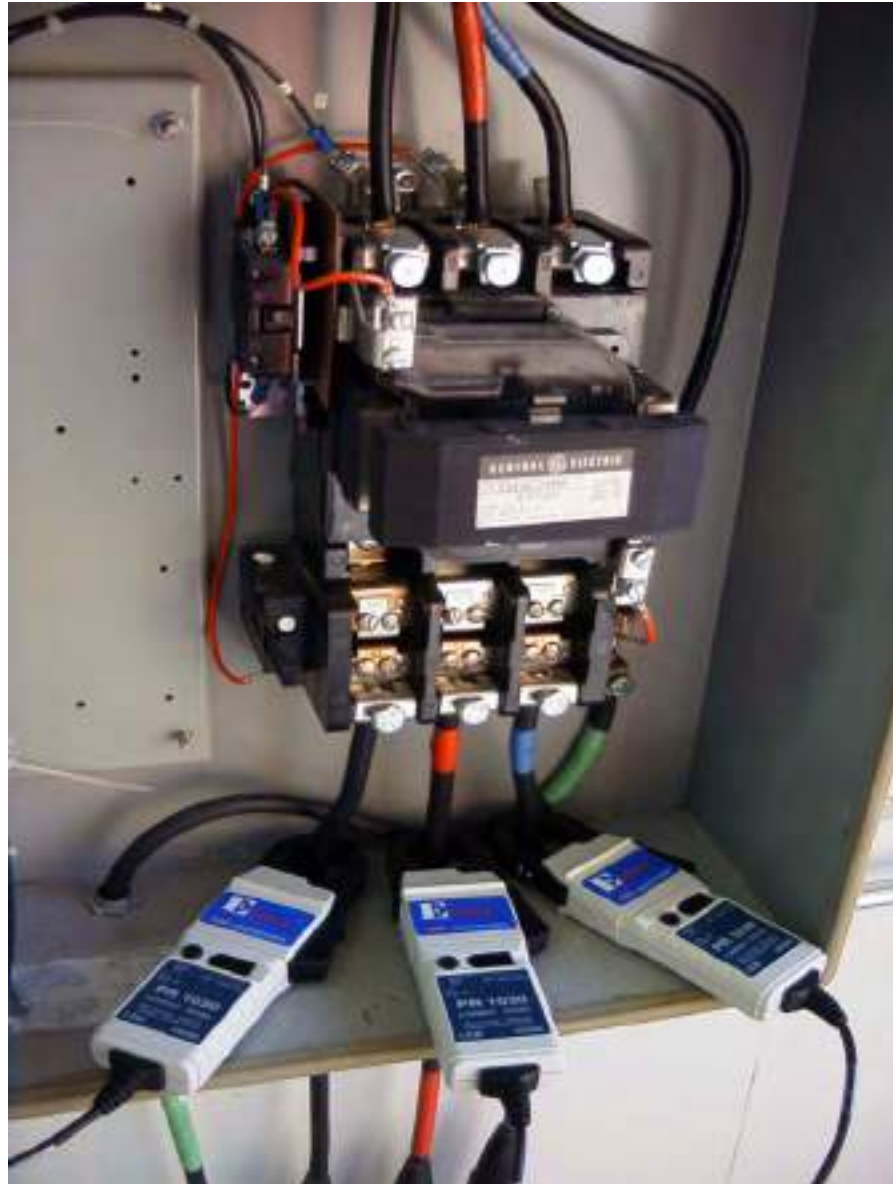
Capturing Current Data

Capturing Current Signals

- Utilizes clamp-on current probes to acquire signals
 - No electrical connections need to be made
 - Equipment operation is not interrupted

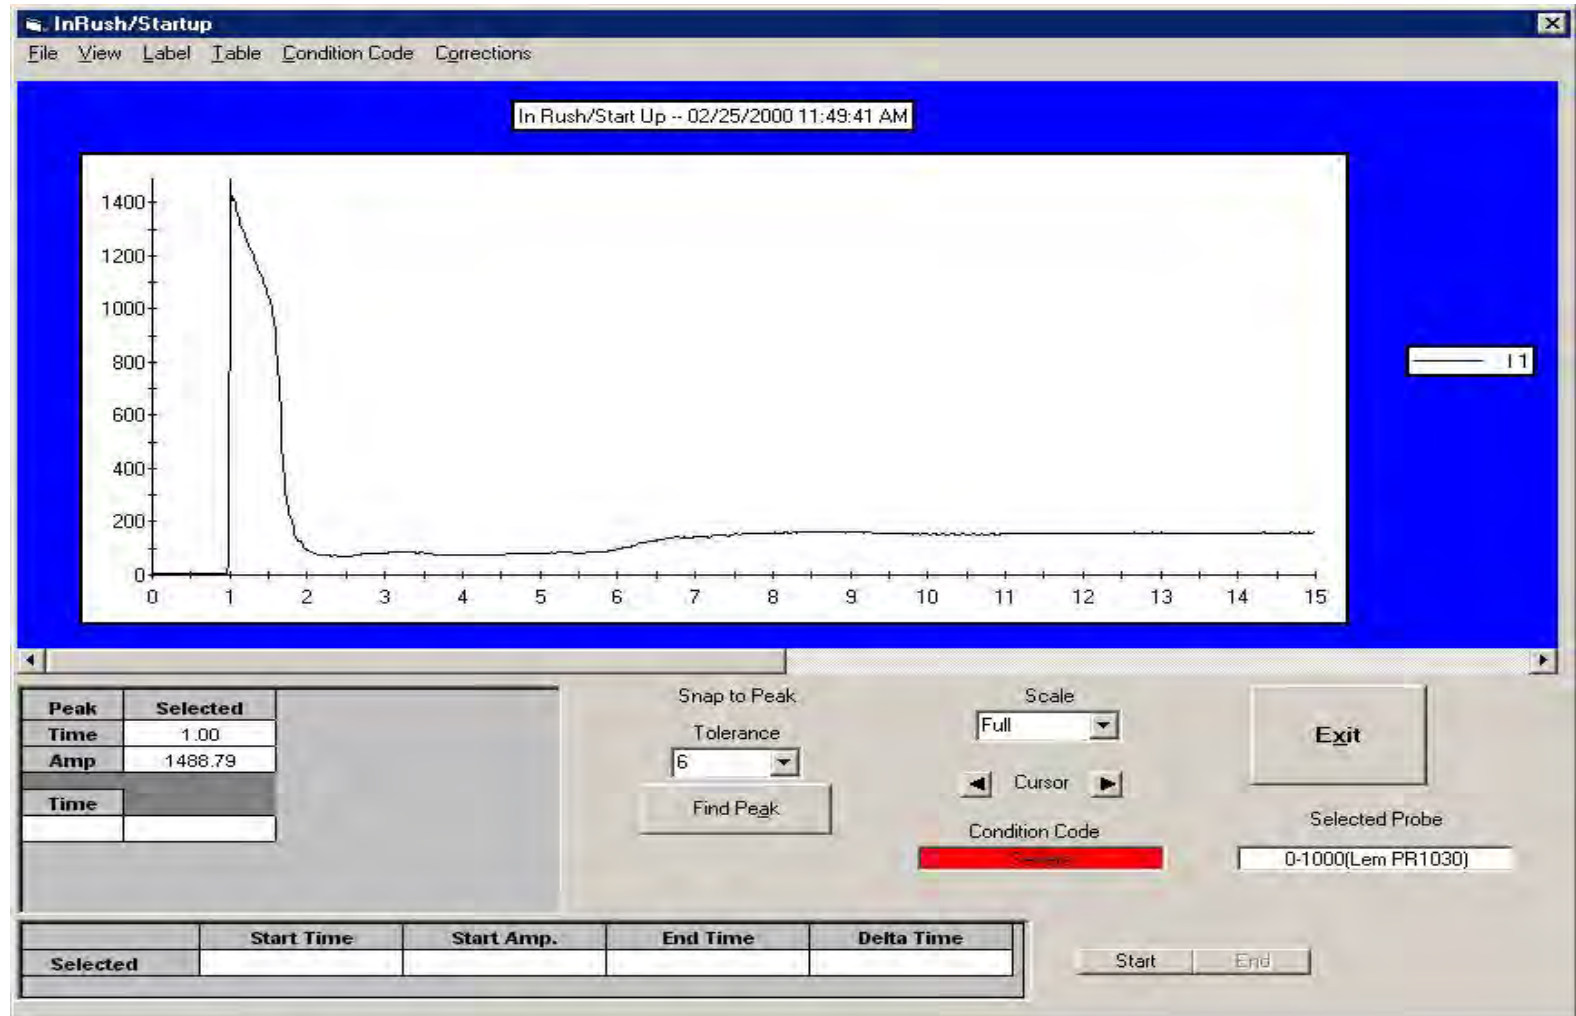
In-Rush Startup Manual Capture

In-Rush Startup

- Perform as often as possible
- Provides valuable information when troubleshooting
- Stator and rotor problems cause changes in the In-Rush Startup profile
 - Peak current
 - Graph shape
 - Duration

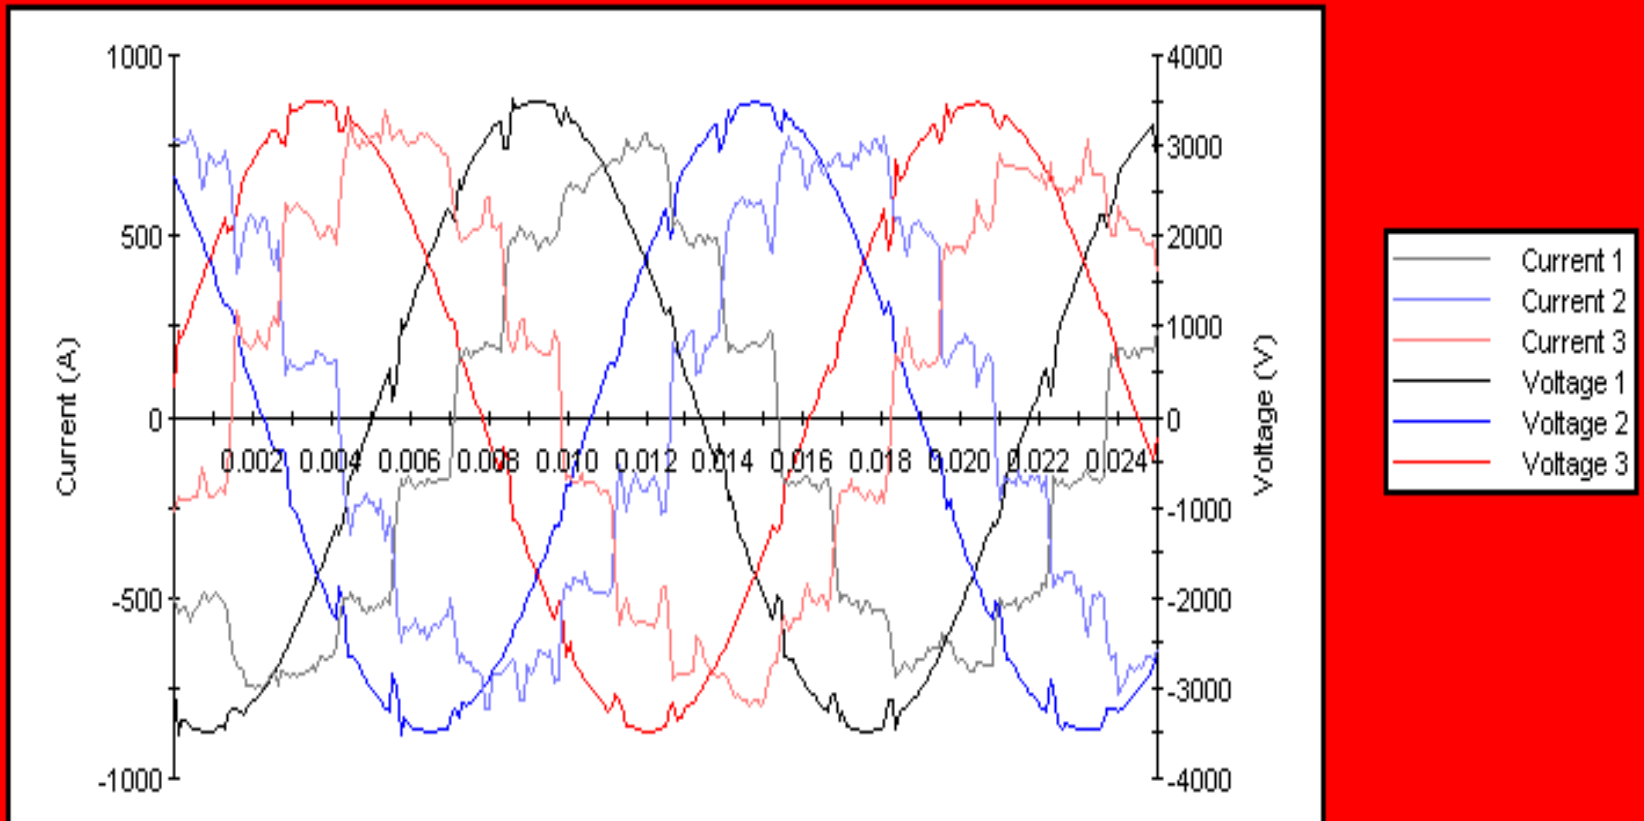
Voltage & Current vs Time -- A Induced Draft Fan 09/21/1999 4:21:50 PM

SCR (Silicon Control Rectifier) VFD Variable Frequency Drives

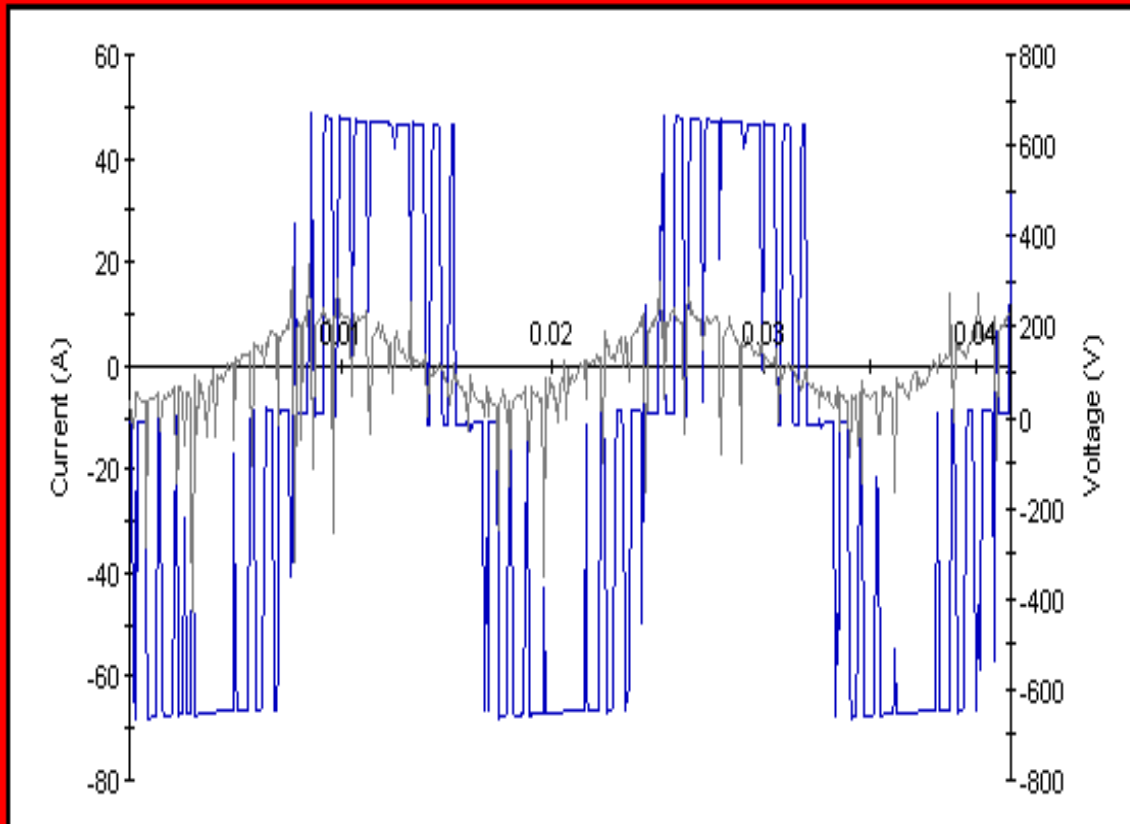
Voltage & Current vs Time -- 3401001 TWO STRAND 08/19/1998 9:55:13 AM

Pulse Width Modulated Inverter

— Current 1
— Voltage 2-3

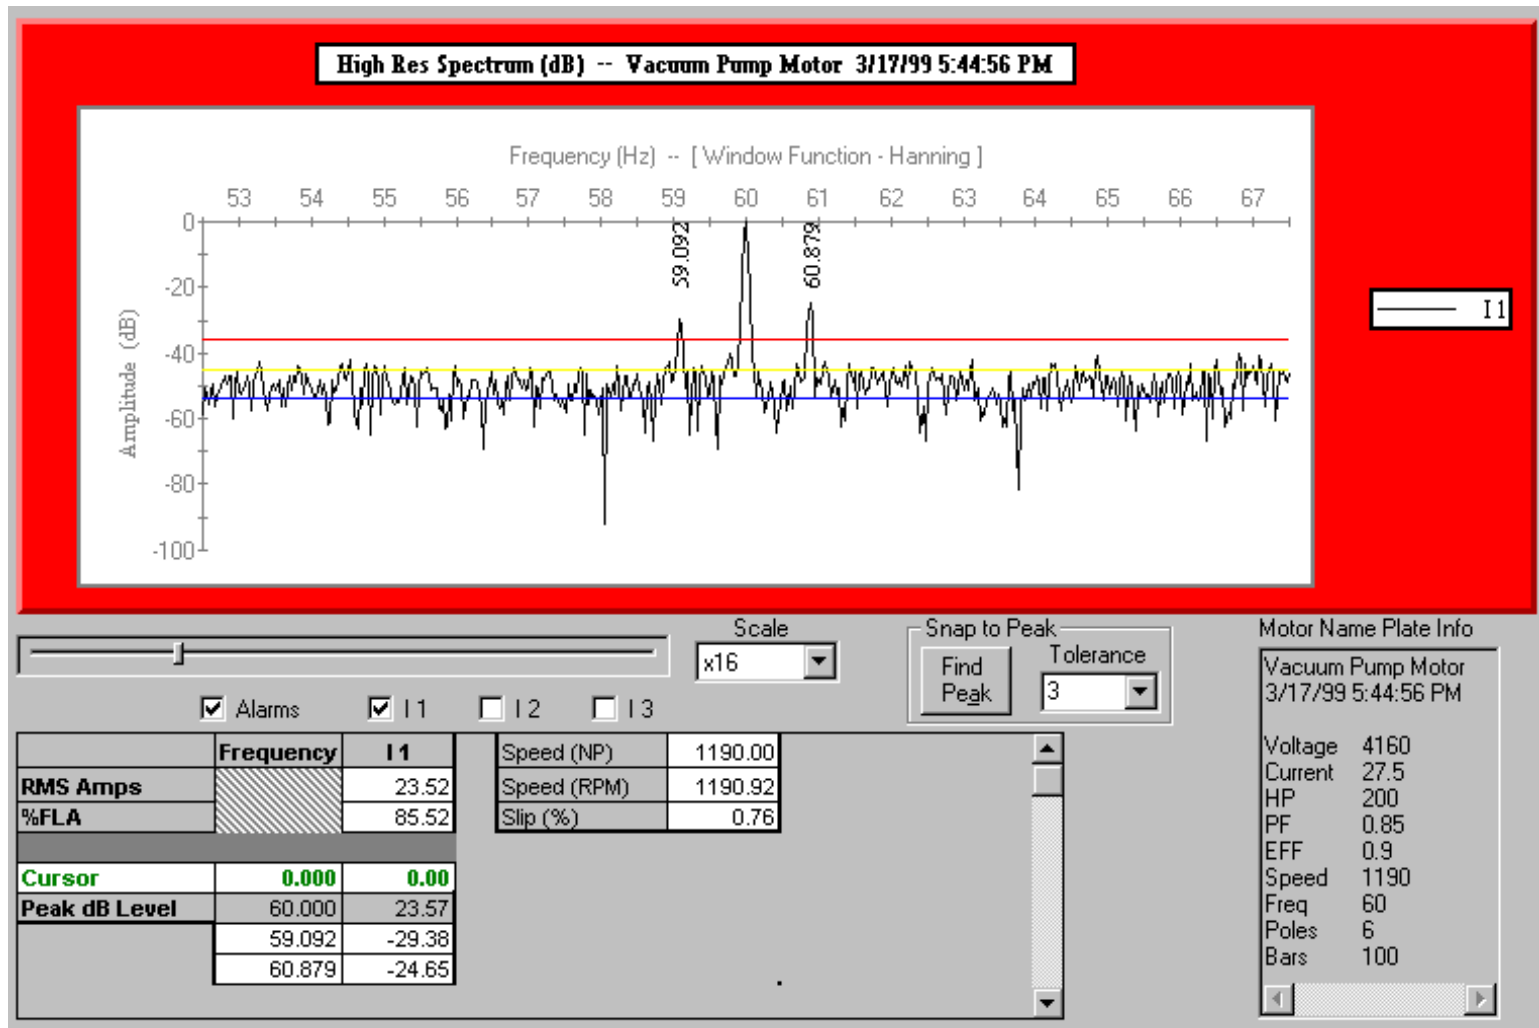
Emax Results

- ◆ Motor was running at high temperatures
- ◆ Vibration levels were above normal but not conclusive
- ◆ Dynamic Testing performed from the CTs

Motor ID:	Vacuum Pump Motor
Circuit:	
Volts:	4160
Horsepower:	200
Manufacturer:	LOUIS ALLIS
Motor Type:	AC Induction
Condition:	Not Assigned

- ◆ Broken Rotor bars for vacuum pump motor
 - ✦ Emax
 - Spectral analysis confirms pole pass sidebands around the fundamental frequency indicating cracked rotor bars
