Case Study at DCAP, Suvarnabhumi Airport

Gas Turbine Generator

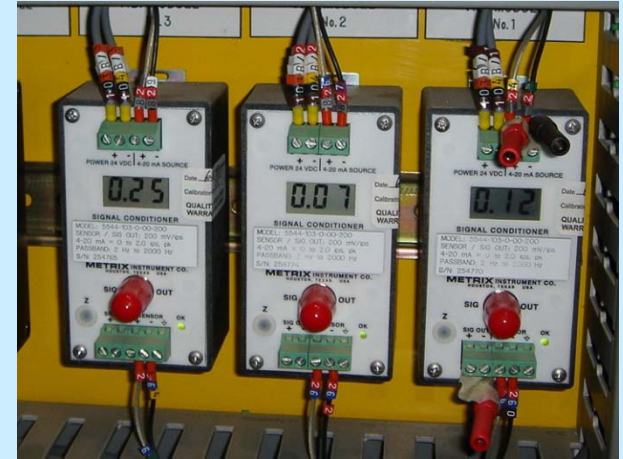
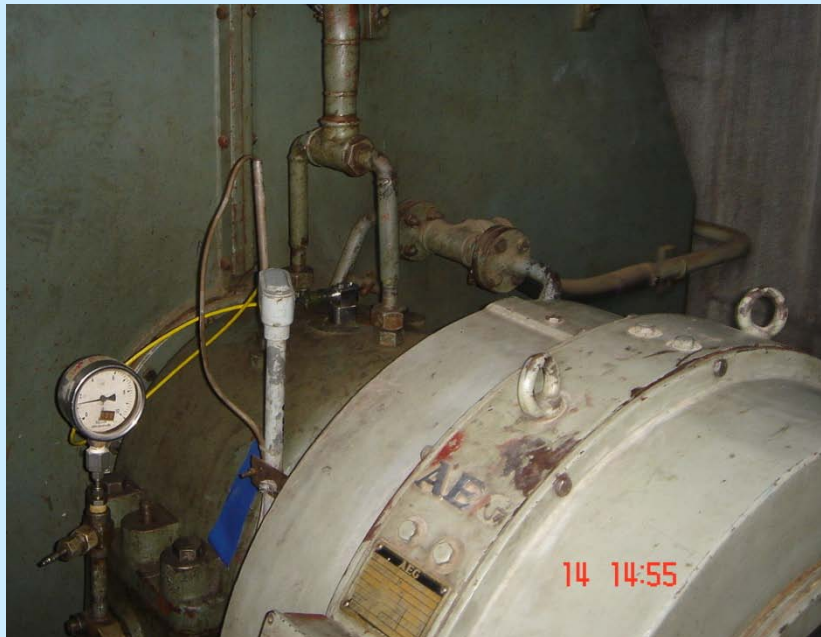
The older system at their generator
non-drive side

Velocity Signal Conditioner model 5544
Seismic Velocity Sensor model 5485C

- More heavy, too difficult to install and calibrate
- Less sturdy due to its components
- Can be induced due to its wire coil inside by near-by Walky-Talky Radio Frequency

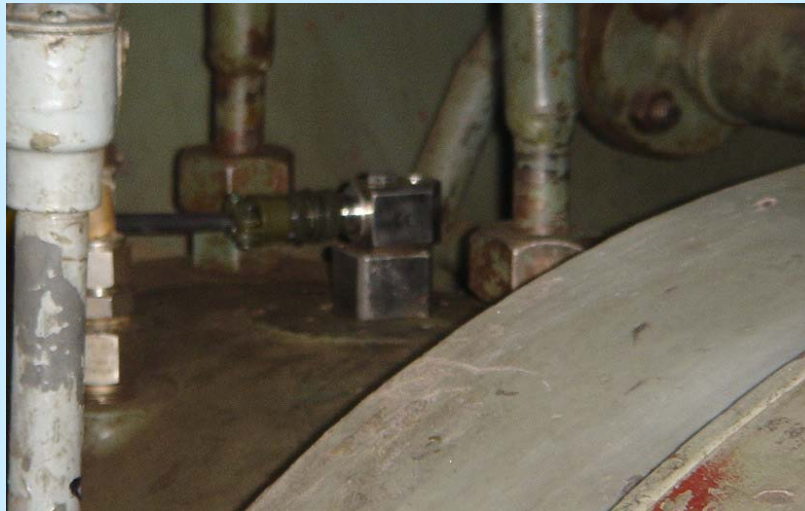
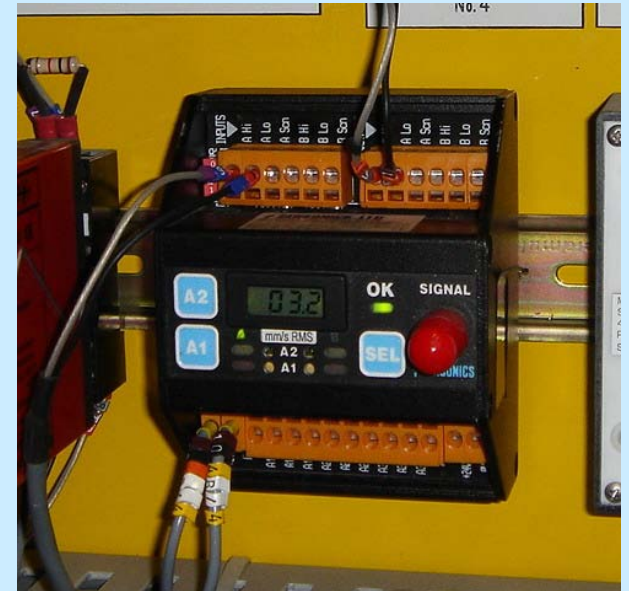
After replacement with our system

Vibration Monitor : Sonosics model DN2601
Accelerometer Sensor : Wilcoxon model 787A

**No more Radio Frequency
Interference!**
