## โรงไฟฟ้าไตรเอนเนอจี ราชบุรี

## Tooth cracked at Bevel Gear in Cooling Tower's Gearbox

### DETAILED SPECTRUM EXCEPTION REPORT

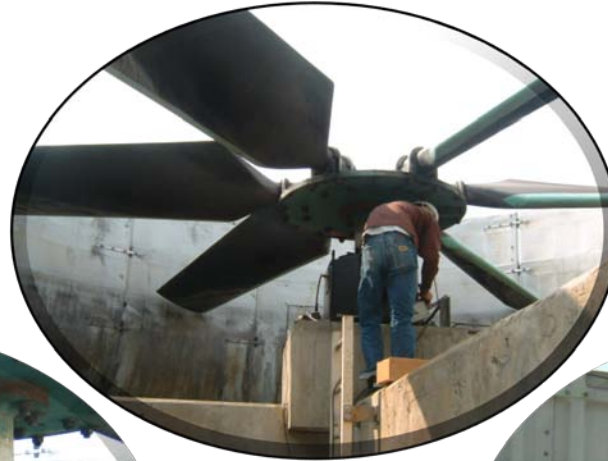
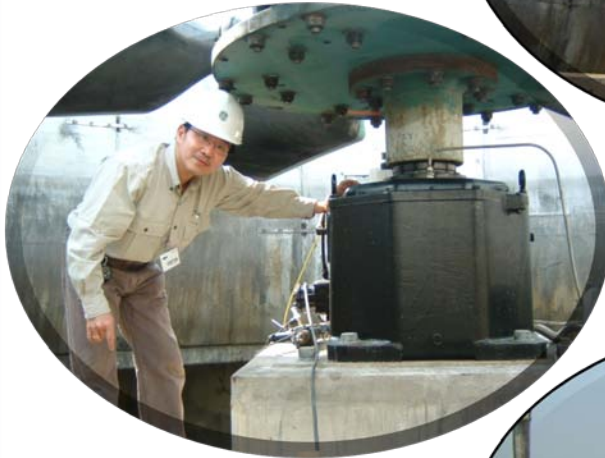
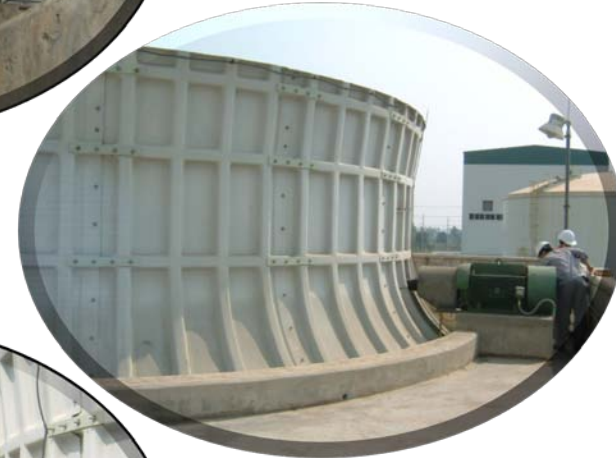
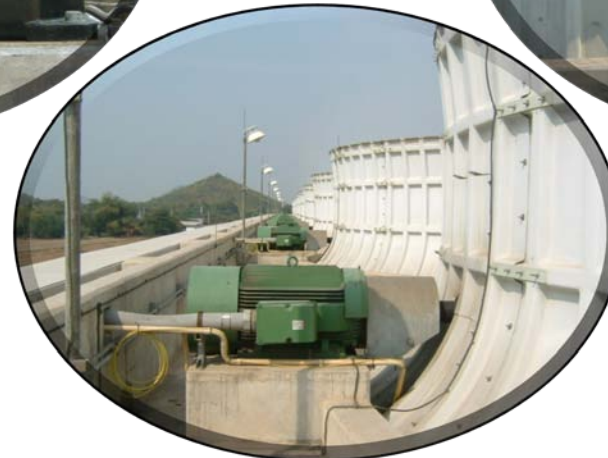
- The Machine is Cooling Tower
- The old system is Vibration Switches
- The switches sometimes work, sometimes not.
- The inspection team can't get the real vibration data from the gearbox and also can't analyze the root cause of the gearbox's problem
- The customer contacted us to propose a better vibration protection system which also provide a remote spectrum analysis to analyze the root cause
- We propose SENSONICS model DN2601 plus general vibration sensor with splash proof connector, all systems have to response the low frequency of the Fan Blade
